## 6.0 Commerce

## 6.4 Commercial Resources Identified During Survey

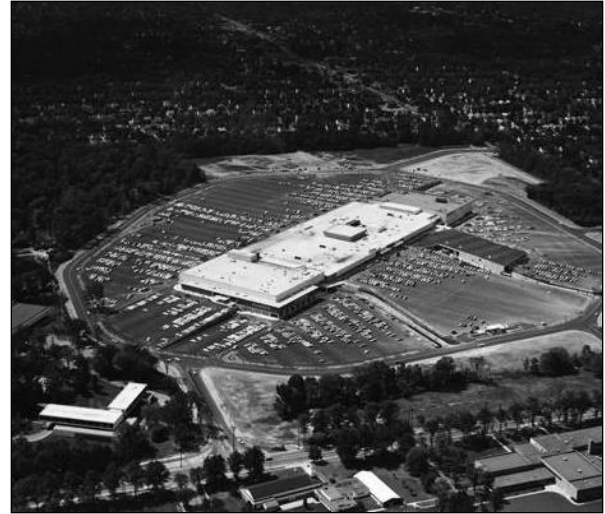
Figure 6-3. 1963 aerial of Severance Town Center, showing its original configuration (Cleveland Press Collection, Michael Schwartz Library, Cleveland State University).

By the early 1960s, fully enclosed malls were preferred by developers, investors, and consumers, and therefore, more of these were constructed over shopping centers and standalone stores (Longstreth 2010:216). In Cuyahoga County, the first fully enclosed mall, Severance Center, was built in the early 1960s in Cleveland Heights on the former 125-acre Longwood Estate of John Severance. The site, just beyond the eastern city limits of Cleveland, was chosen because of the openness of the estate (not many buildings or structures would need to be razed) and because the estate had passed to Severance's nephew, Severance Millikin, who wanted to develop the land. Plans for the Severance Mall began in 1954, and was the first mall constructed in Ohio. The mall officially opened in 1963 with local department stores, Halle's and Higbee's as the anchor shops. Other malls followed throughout Cuyahoga County into the late 1970s.

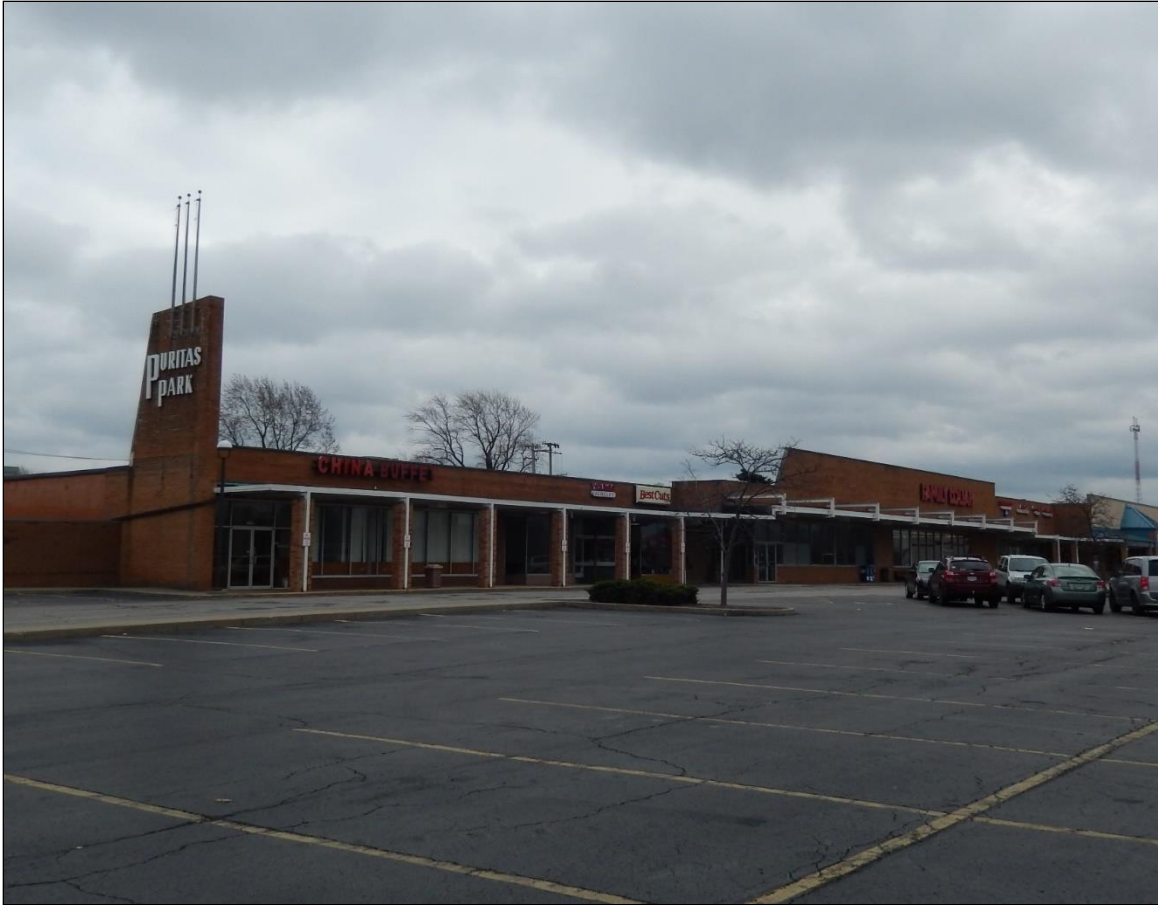
Plate 2. Puritas Plaza Shopping Center (CUY 1146208), constructed in 1959, 14025 Puritas Ave., Puritas-Longmead. The Family Dollar store on the right originally housed an A&P supermarket. Grocery stores were commonly found in shopping centers during the modern period.

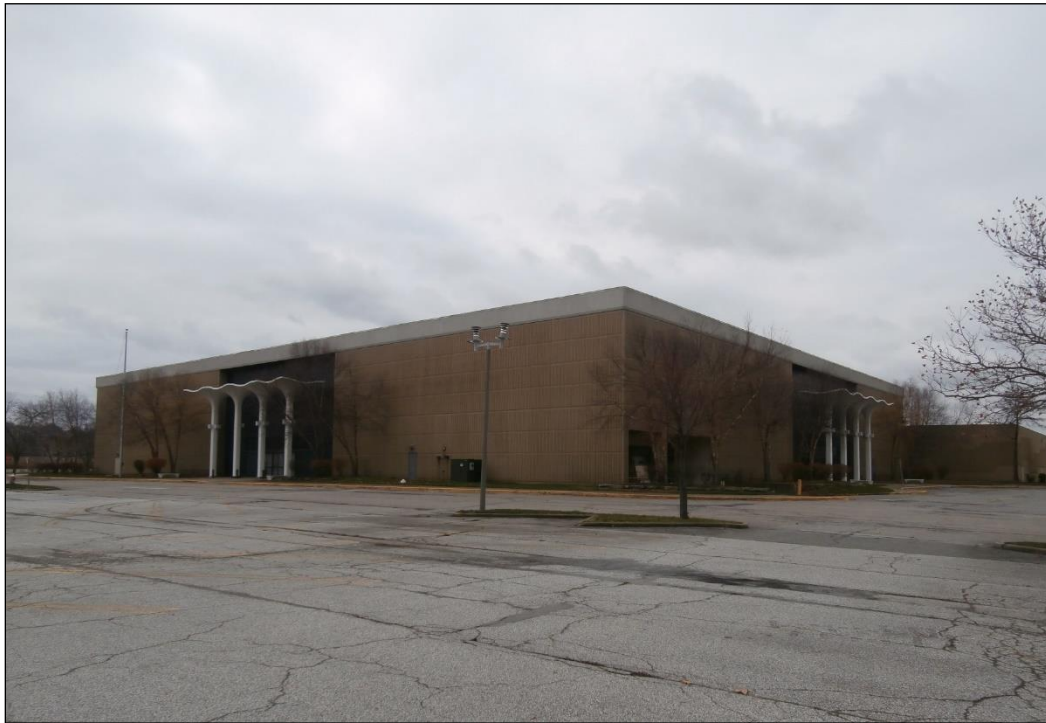
Plate 3. Euclid Square Mall (CUY 1104522), constructed in 1976, Euclid. Currently mostly vacant with no remaining retail stores; however, this former anchor store end retains its original entry columns.

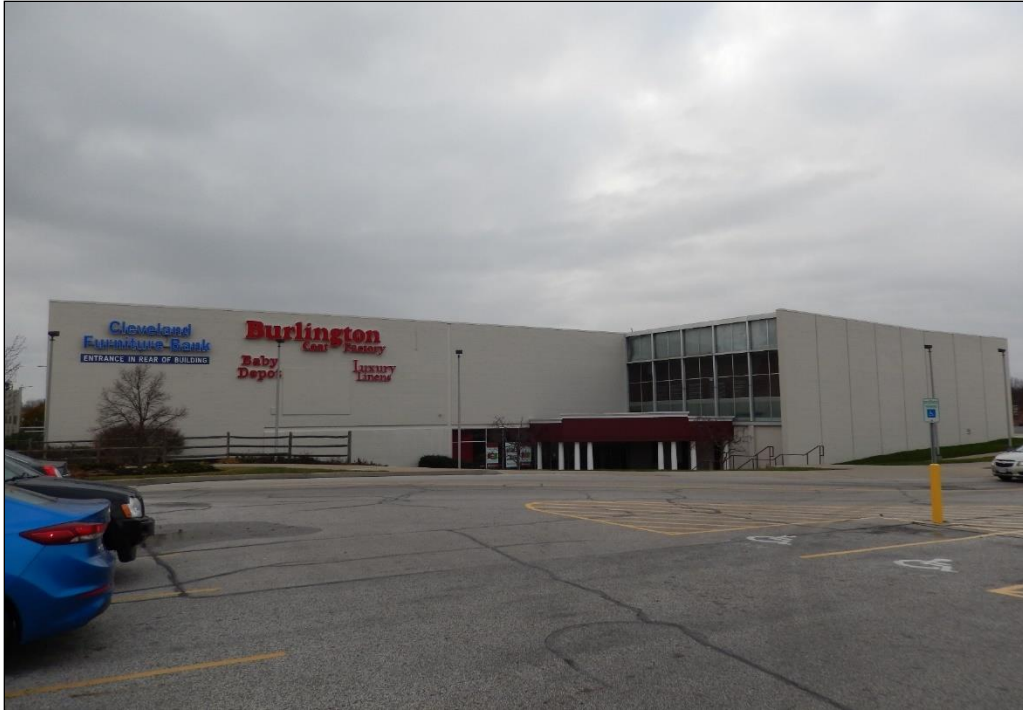
Plate 4. Former Halle's Brothers Department Store branch (CUY 1140715), constructed in 1956, Middleburg Heights. This was the only former branch store identified during survey.

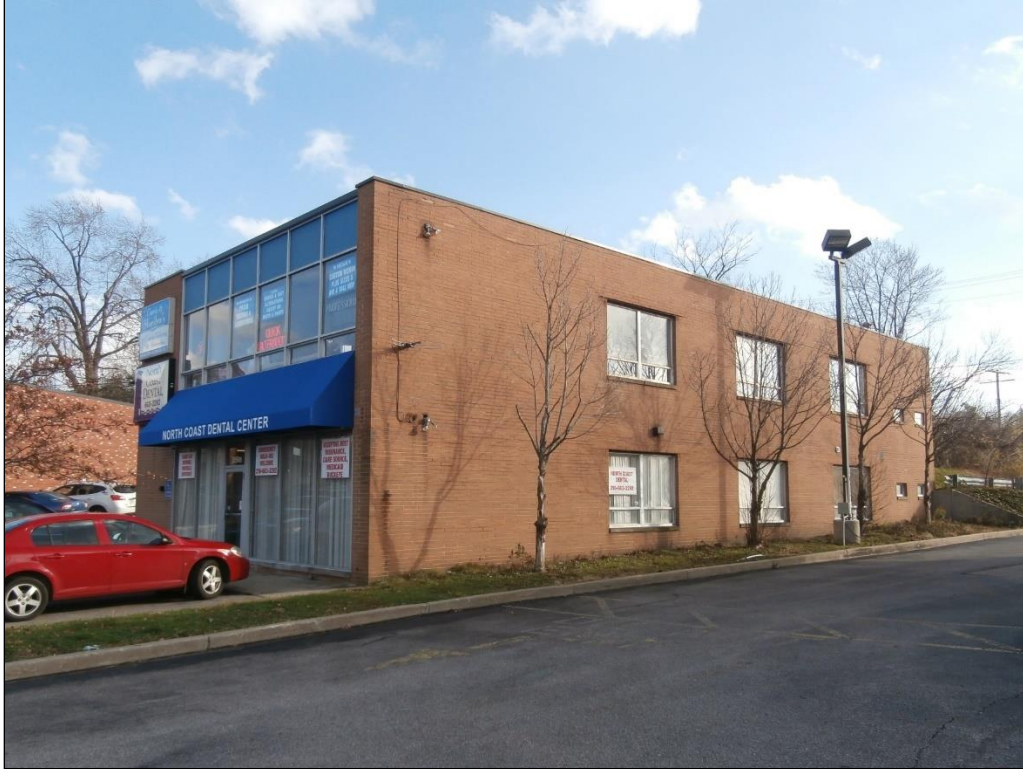
Plate 5. Small retail store (CUY 1134624), constructed in 1964, 20508 Southgate Park Blvd., Maple Heights. The building retains most original materials.

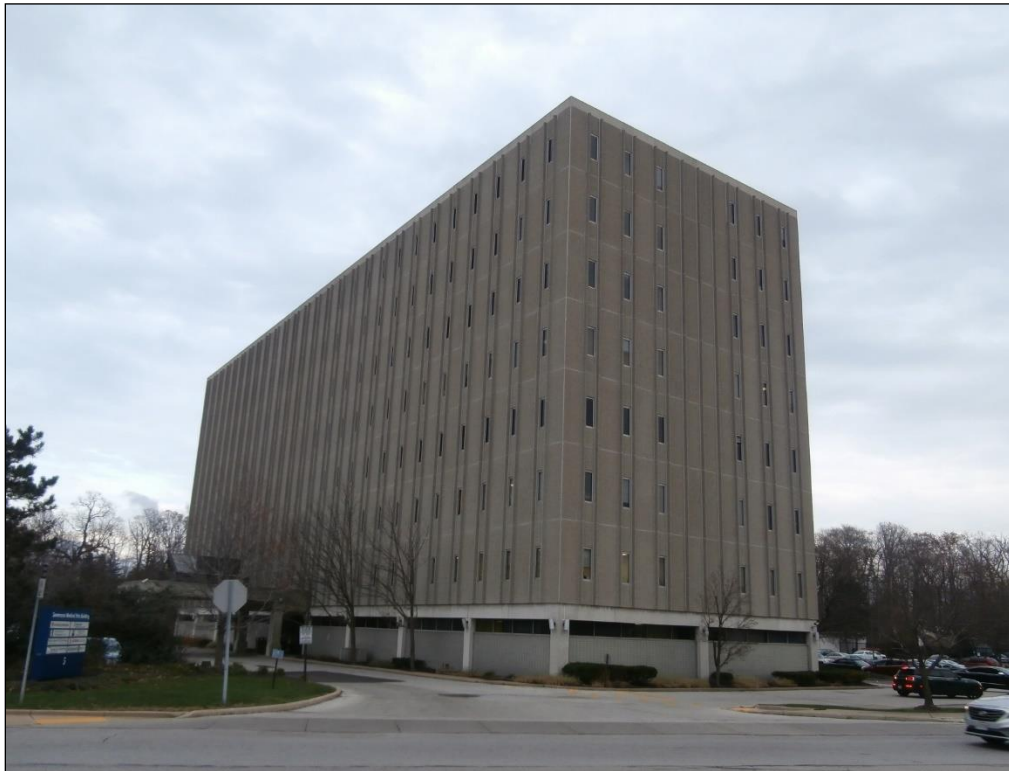
Plate 6. Severance Medical Arts Building (CUY 1134022), constructed in 1966, 5 Severance Cir., Cleveland Heights. The building was constructed shortly after the Severance Center Mall on the same large parcel.

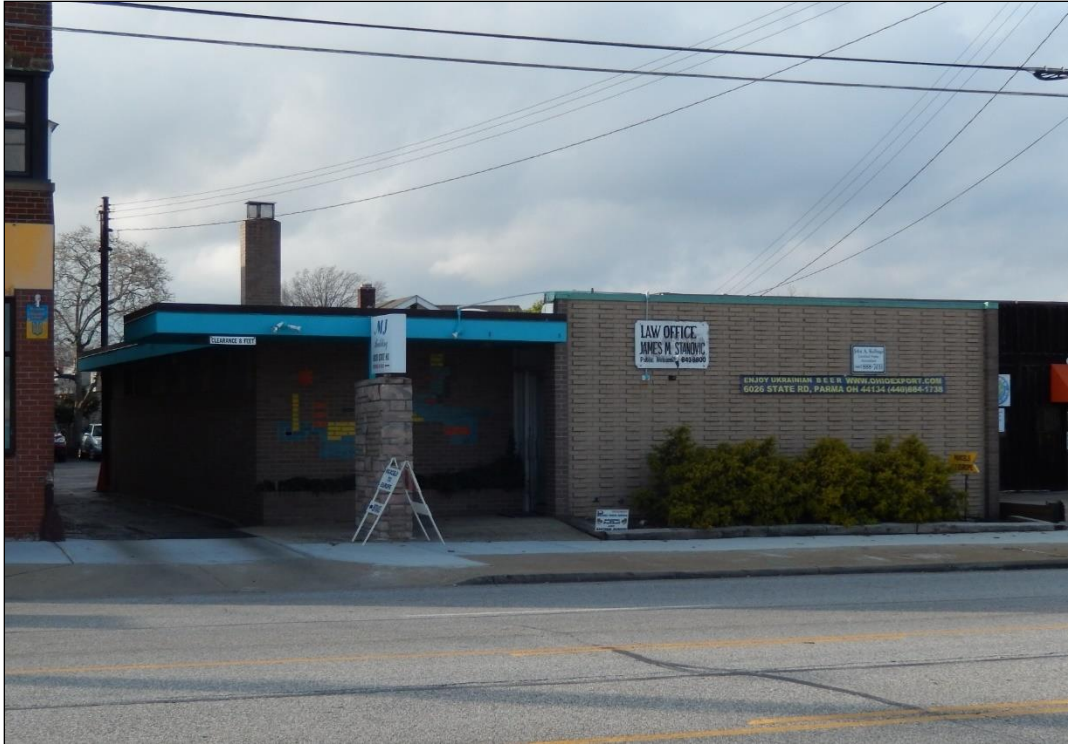
Plate 7. MJ Building (CUY 1145417), constructed in 1956, 6020 State Rd., Parma. The building was advertised as ideal for small medical offices, and currently houses law and accountant offices.

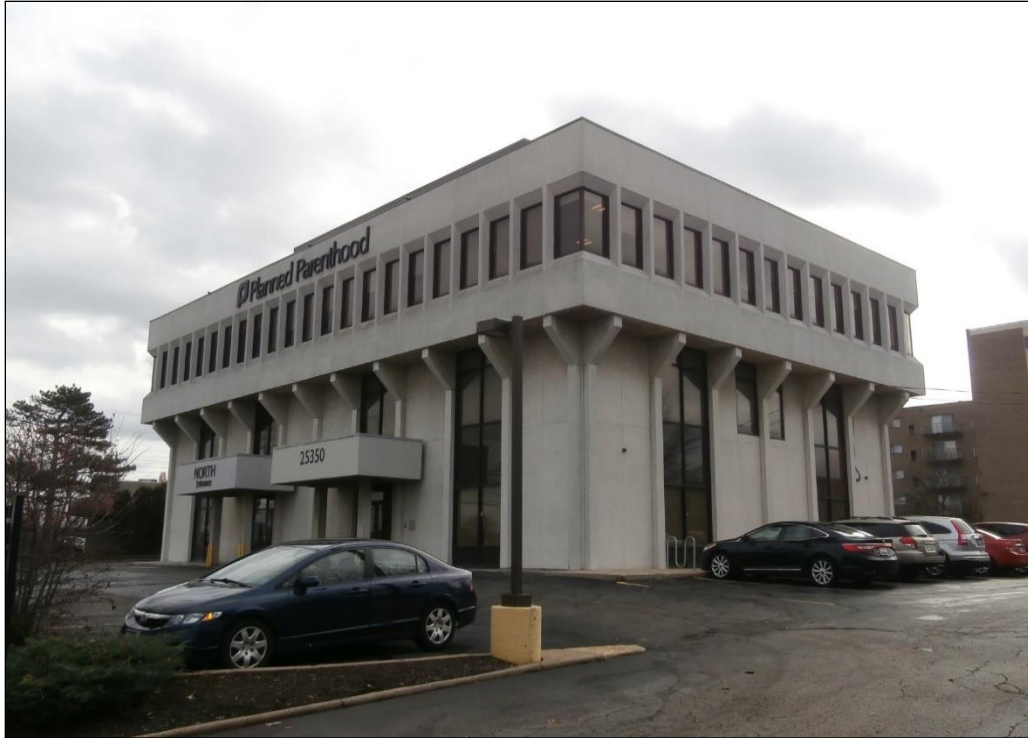
Plate 8. Former Park View Federal Savings & Loan Association building (CUY 1133824), constructed in 1960, 25350 Rockside Rd., Bedford Heights. The building was a bank into the 1990s; drive-thru windows are extant on the opposite wall.

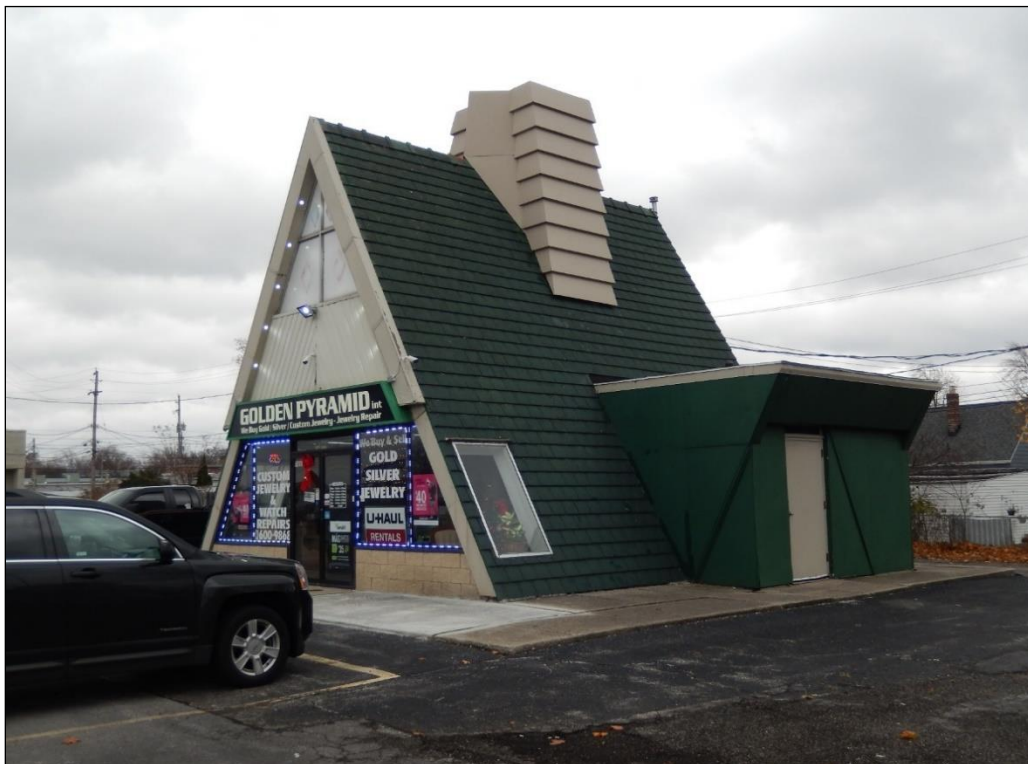
Plate 9. Former Golden Point Drive-In franchise restaurant, now retail store, (CUY 1141717), constructed ca. 1960, 7467 Memphis Ave., Brooklyn. The building's small footprint and unusual, A-frame design suggested it was originally constructed for another use.

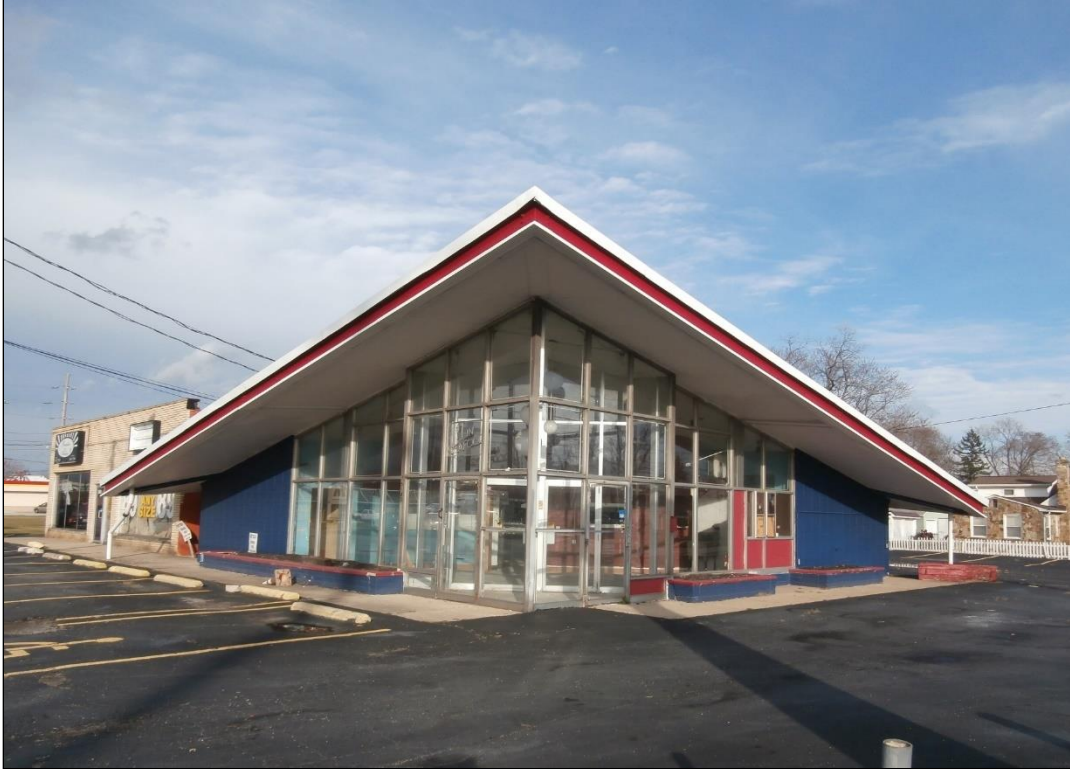
Plate 10. Former location of Jolly Roger Donuts, and most recently a seafood restaurant, but currently vacant (CUY 1130124), constructed in 1958, 5145 Northfield Road, Bedford Heights.

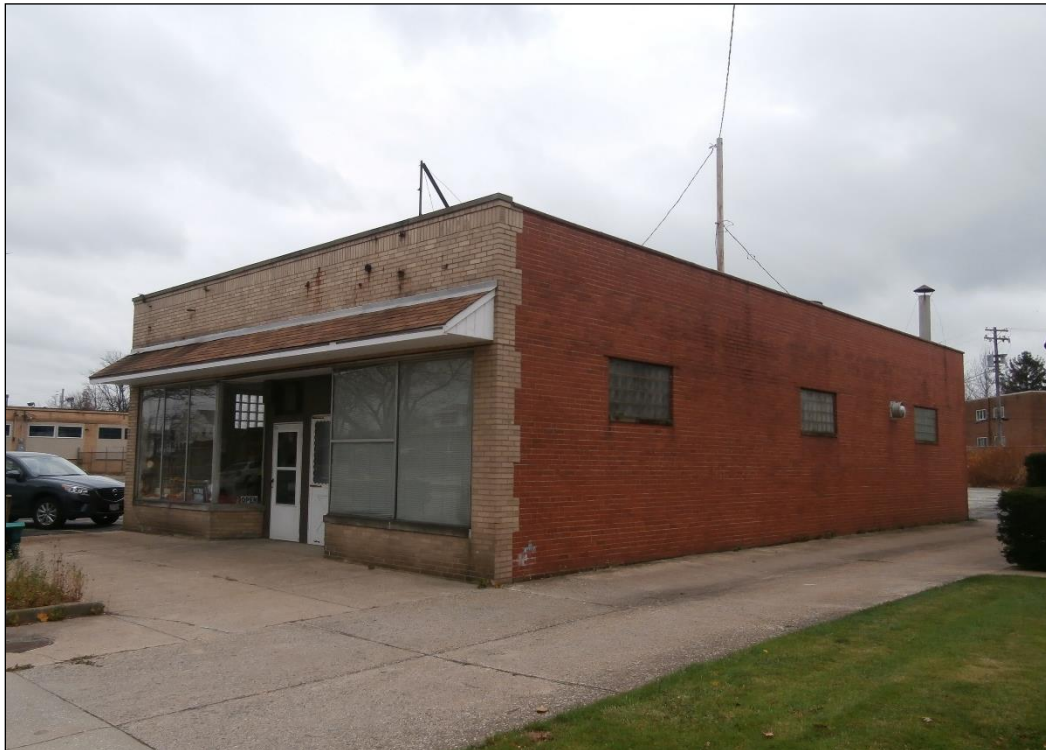
Plate 11. Commercial building (CUY 1120611), constructed in 1950, 512-514 E. 185<sup>th</sup> Street, Cleveland. This building is split into two storefront areas and has housed a pet store and laundromat. The left half is currently a bakery and the right half is vacant.
